ADVERTENCIA 042/DAG

MOTIVO: Posibilidad de falla en elementos de montaje del timón de dirección.

D-2004-348R1

Rudder – lower mounting of the rudder

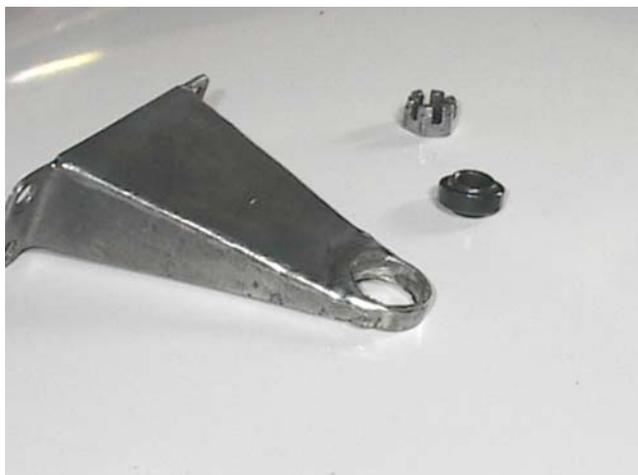
Sin embargo, el 01-NOV-04 ocurrió un accidente con un planeador DG-200 del Club de Planeadores Zárate, en el cual, luego del despegue, se desprendió el timón de dirección como consecuencia de haberse salido el rodamiento de su alojamiento en el soporte inferior de dicha superficie de comando. Es de destacar que dicho planeador no tenía a la fecha del accidente, la arandela de seguridad instalada.

En la fotografía de la izquierda puede observarse el rodamiento (tipo rótula) que viene "clavado" con tiraje en el soporte inferior, tal como fue recuperado luego que el planeador aterrizara.

- 1º) A los TAR, que en ocasión del ingreso de planeadores y motoplaneadores DG-100, DG-200, DG-400 y DG-600, se cumplimente la instalación de la arandela de seguridad, por más que reste tiempo a la fecha límite estipulada en la AD N° D-2004-348R1 de la LBA.

- 2º) A los propietarios/operadores, que tengan en cuenta que antes de cada vuelo deben inspeccionar el rodamiento del soporte inferior del timón de dirección, de acuerdo con la ACTION 1 de la AD. El rodamiento está correctamente clavado cuando su aro exterior está a nivel con la superficie superior del soporte. No obstante esta inspección, se recomienda llevar lo antes posible el planeador a su TAR de confianza, para que se le dé cumplimiento a la instalación de la arandela de seguridad, máxime teniendo en cuenta que su cumplimiento no debería ocasionar gastos elevados.

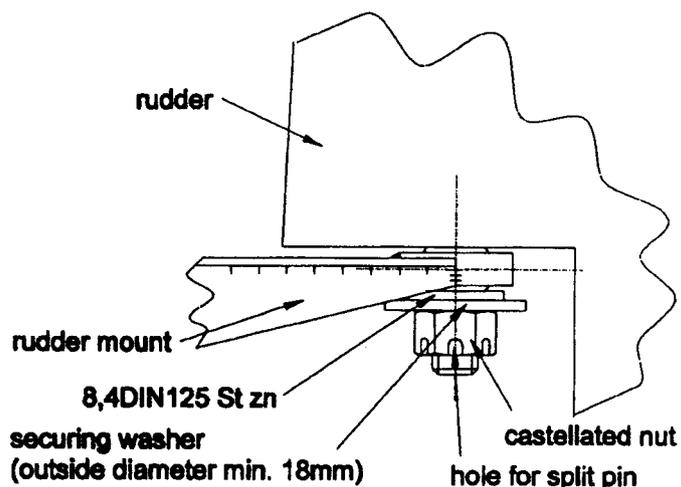
3. Check if a securing washer (min. outside diameter 18mm, 0.71 inch) is installed according to the sketch.
 - a) If yes: The execution of this TN can be entered in the aircraft logs by a licensed inspector without further work to be done.

- b) If no: Remove the castellated nut, install the washer 8.4 DIN9021 and reinstall the nut.
 1. Check if the washer is interfering with the rudder mount. If yes, use a washer 6,4DIN9021 St zn instead, enlarge the 6mm hole to 8mm to enable installation.

2. Check if the split pin can be installed. If yes, secure with a new split pin 2x20 DIN94 zn.

If this is not possible, mark the position for a new hole and remove the rudder.
Drill a new hole (diameter 2mm, .08 inch) 90° to the existing hole.
Reinstall the rudder, use new split pins.
