ADVERTENCIA 058/DAG

MOTIVO: Posibilidad de fractura de bielas del motor por hallarse por debajo de las tolerancias mínimas recomendadas por el fabricante.

TELEDYNE CONTINENTAL[®] AIRCRAFT ENGINE
CRITICAL SERVICE BULLETIN
 Compliance Necessary To Maintain Safety

SUBJECT: IO-360, TSIO-360 AND LTSIO-360 SERIES ENGINE CONNECTING ROD INSPECTION AND REPLACEMENT.

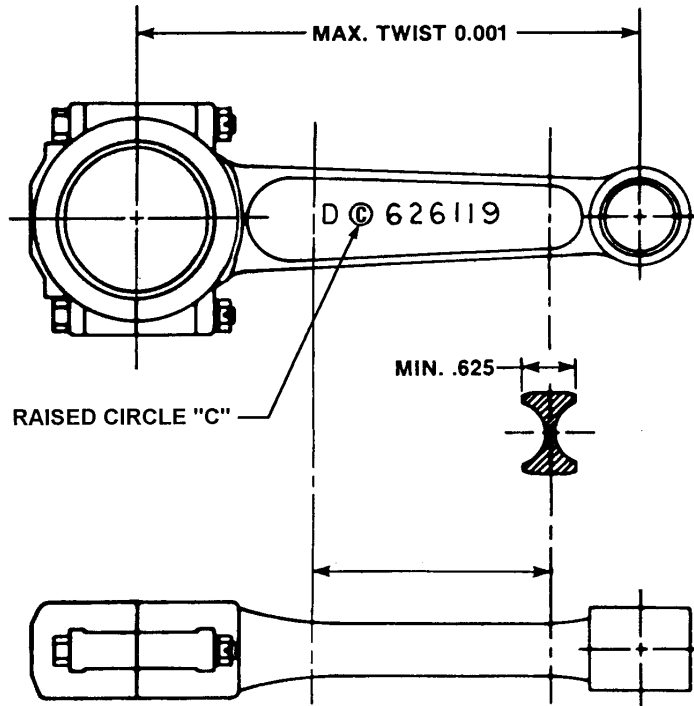
FIGURE 1. CONNECTING ROD.

- Remove all cylinders in accordance with the applicable TCM Overhaul Manual.
- Inspect each connecting rod while it is positioned at its maximum stroke to allow clearance from the crankcase. Measure the beam width as indicated in Figure 1 and record the forging number.
- Any connecting rod that has a beam width less than .625 inch must be replaced. See Figure 1.

NOTE: Connecting rods are supplied in pairs due to the maximum weight differential of 14 grams in opposing cylinder bays. Therefore, the opposite cylinder connecting rod will also require replacement. Reference Table 1 for the applicable replacement connecting rod kit.
