## **ADVERTENCIA 062/DAG**

Posible deterioro de partes del sistema de combustible por la utilización de combustible del tipo automotor (AUTOGAS).

**SUBJECT:** CARBURETOR, BENDIX-STROMBERG MODELS NA-S3A1, NA-S3B AND NA-S03A1 – FLOAT NEEDLE VALVE P/N 390077 – REPLACEMENT OF.

**SUBJECT:** REPLACEMENT OF COMPOSITE FLOATS WITH METAL FLOATS

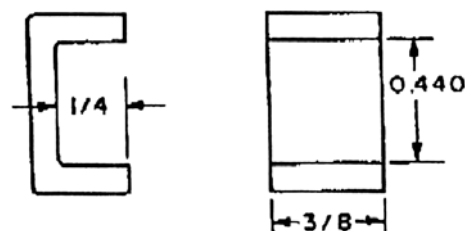
**Figure 1**

**MATERIAL: 3/32 INCH  
THICK BRASS**

1. At time of carburetor overhaul, replace the rubber tipped stainless steel float needle valve P/N 390077 with the new Delrin plastic needle valve P/N 2523047.
2. The needle seat, P/N 383911, 383912 or 384585 as applicable (see application), need not be replaced unless the valve contact area on the seat has been damaged or deformed to the extent that the seat is no longer considered to be serviceable.
3. The Delrin needle requires a weight added to the float lever. The weight must weigh approximately four grams. Refer to Figure 1 for instructions for fabrication of the weight. Soft solder the weight to the float lever in the location indicated in Figure 2. Use a 300 or 500 watt electric iron for this soldering operation to get the solder to flow. Keep the float and lever wrapped in a wet cloth to prevent melting other solder joints.

Be certain the added weight does not strike the aluminum carburetor bowl at any position of the float. Some corners of the added weight will have to be tailored for clearance.
