**DIRECCION NACIONAL DE AERONAVEGABILIDAD (DNA)
DIRECCION CERTIFICACION AERONAUTICA (DCA)
REPUBLICA ARGENTINA**

ADVERTENCIA 096/DCA

APLICABLE A: Aeronaves equipadas con alternadores Kelly Aerospace P/N DOFF10300 Series.

MOTIVO: Retorqueo de los bulones de ensamble del alternador a intervalos regulares.

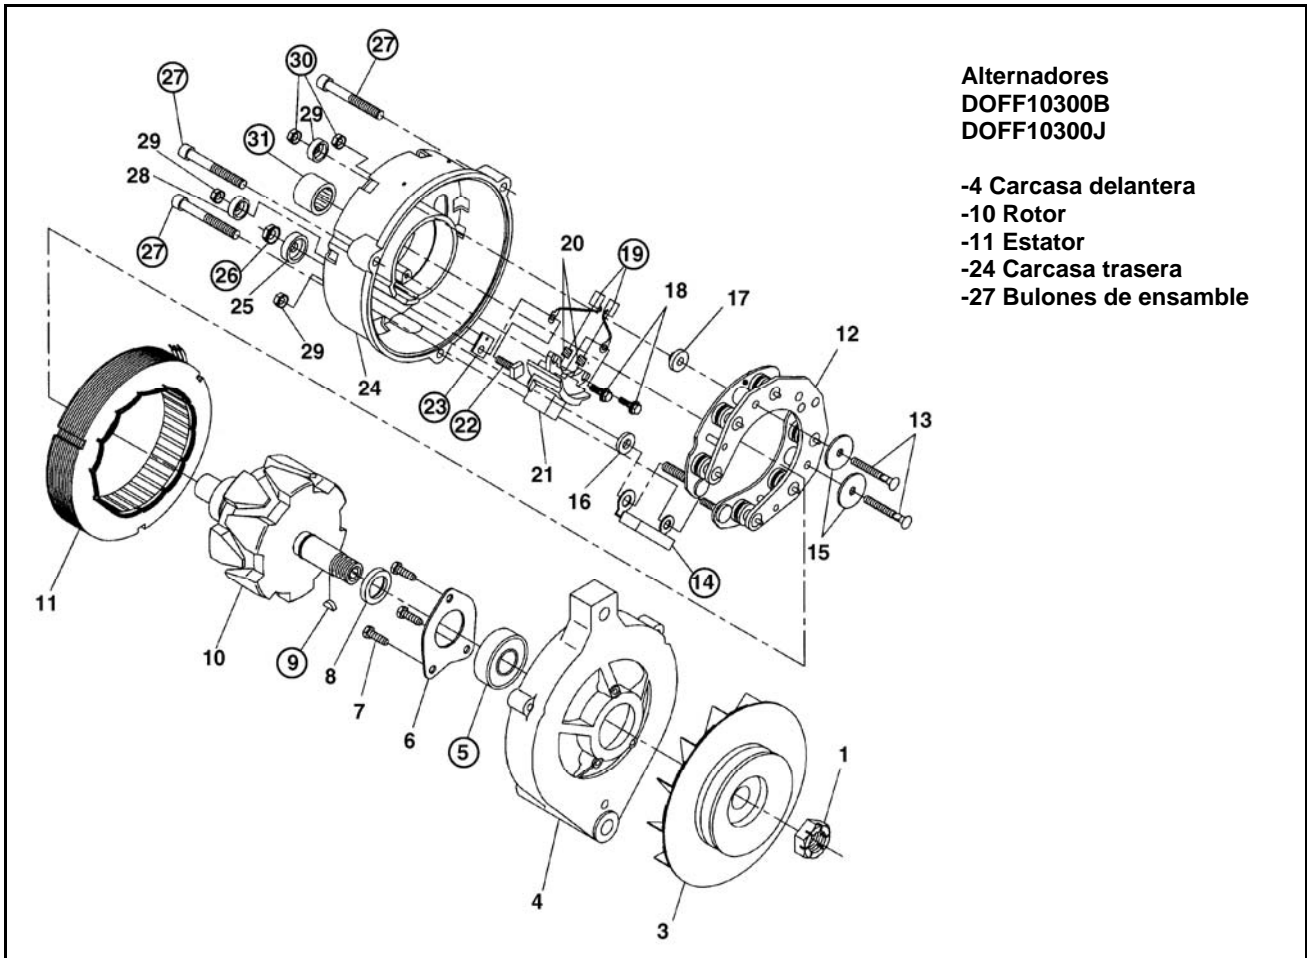
**Alternadores
DOFF10300B
DOFF10300J**

ANTECEDENTES: Esta Advertencia pone en conocimiento del público usuario el Continuing Airworthiness Notice (CAN) N° 24-001 del 02-Julio-2008, emitido por la Autoridad de Aviación Civil de Nueva Zelanda, debido a fallas operativas eléctricas reportadas en alternadores Kelly Aerospace a las pocas horas de funcionamiento, atribuidas a vibración del motor que causó la pérdida del torque en los bulones de ensamble debido a desgaste metálico en/entre las carcasas y/o el estator.

- 4 Carcasa delantera
- 10 Rotor
- 11 Estator
- 24 Carcasa trasera
- 27 Bulones de ensamble

RECOMENDACION: Esta Dirección recomienda seguir las instrucciones de mantenimiento del fabricante del alternador, que indica un retorqueo inicial de los bulones de ensamble a las 10 horas y posteriormente a intervalos regulares que no excedan las 100 horas de tiempo en servicio, a un valor de 30-35 Libras-pulgadas.

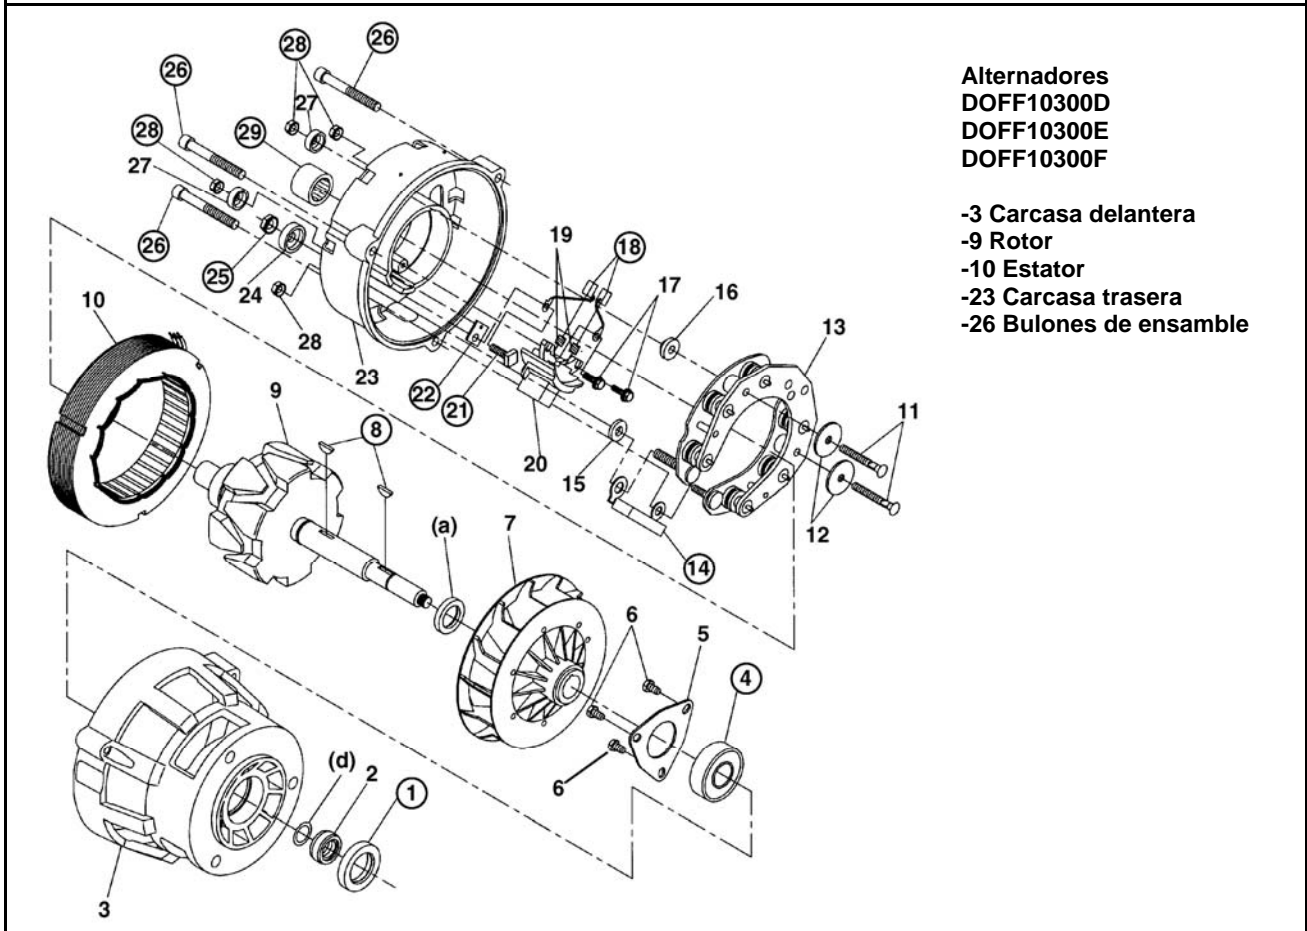
**Alternadores
DOFF10300D
DOFF10300E
DOFF10300F**

- 3 Carcasa delantera
- 9 Rotor
- 10 Estator
- 23 Carcasa trasera
- 26 Bulones de ensamble

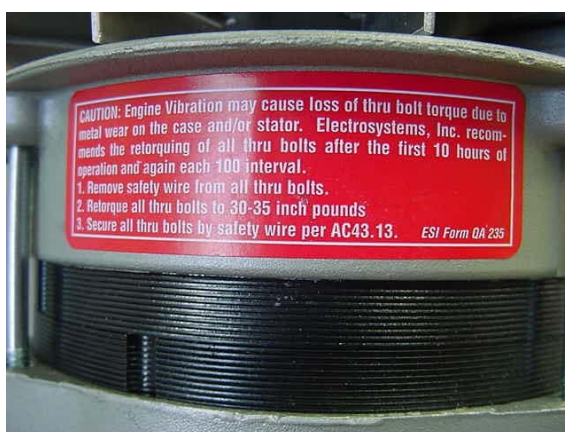
Recently the manufacturer included a decal on the casing of the alternator specifying the above mentioned maintenance instructions.

This CAN alerts operators of aircraft fitted with Kelly Aerospace alternators P/N DOFF10300 series of the manufacturer maintenance instructions. When a new/rebuilt/exchange alternator is fitted, the manufacturer requires the retorque of alternator thru bolts after the initial 10 hours TIS, and thereafter at intervals of 100 hours TIS. The CAA recommends the alternator bolts are retorqued at intervals of 50 hours TIS. The retorque interval can be extended to 100 hours TIS when it can be determined that there is no significant loss of alternator thru bolt torque at 50 hour intervals which could result in alternator failure. Remove the safety lock wire, loosen the bolts to break the torque, and determine the running torque value of each bolt. Retorque the alternator thru bolts to 30 to 35 inch pounds in addition to the running torque value. Secure all thru bolts with lock wire in accordance with an approved method.
