ADVERTENCIA 097/DCA

APLICABLE A: Helicópteros Robinson R44 II.

MOTIVO: Pérdidas de combustible a través de conexiones con insuficiente torque.

Continuing Airworthiness Notice – 28-005

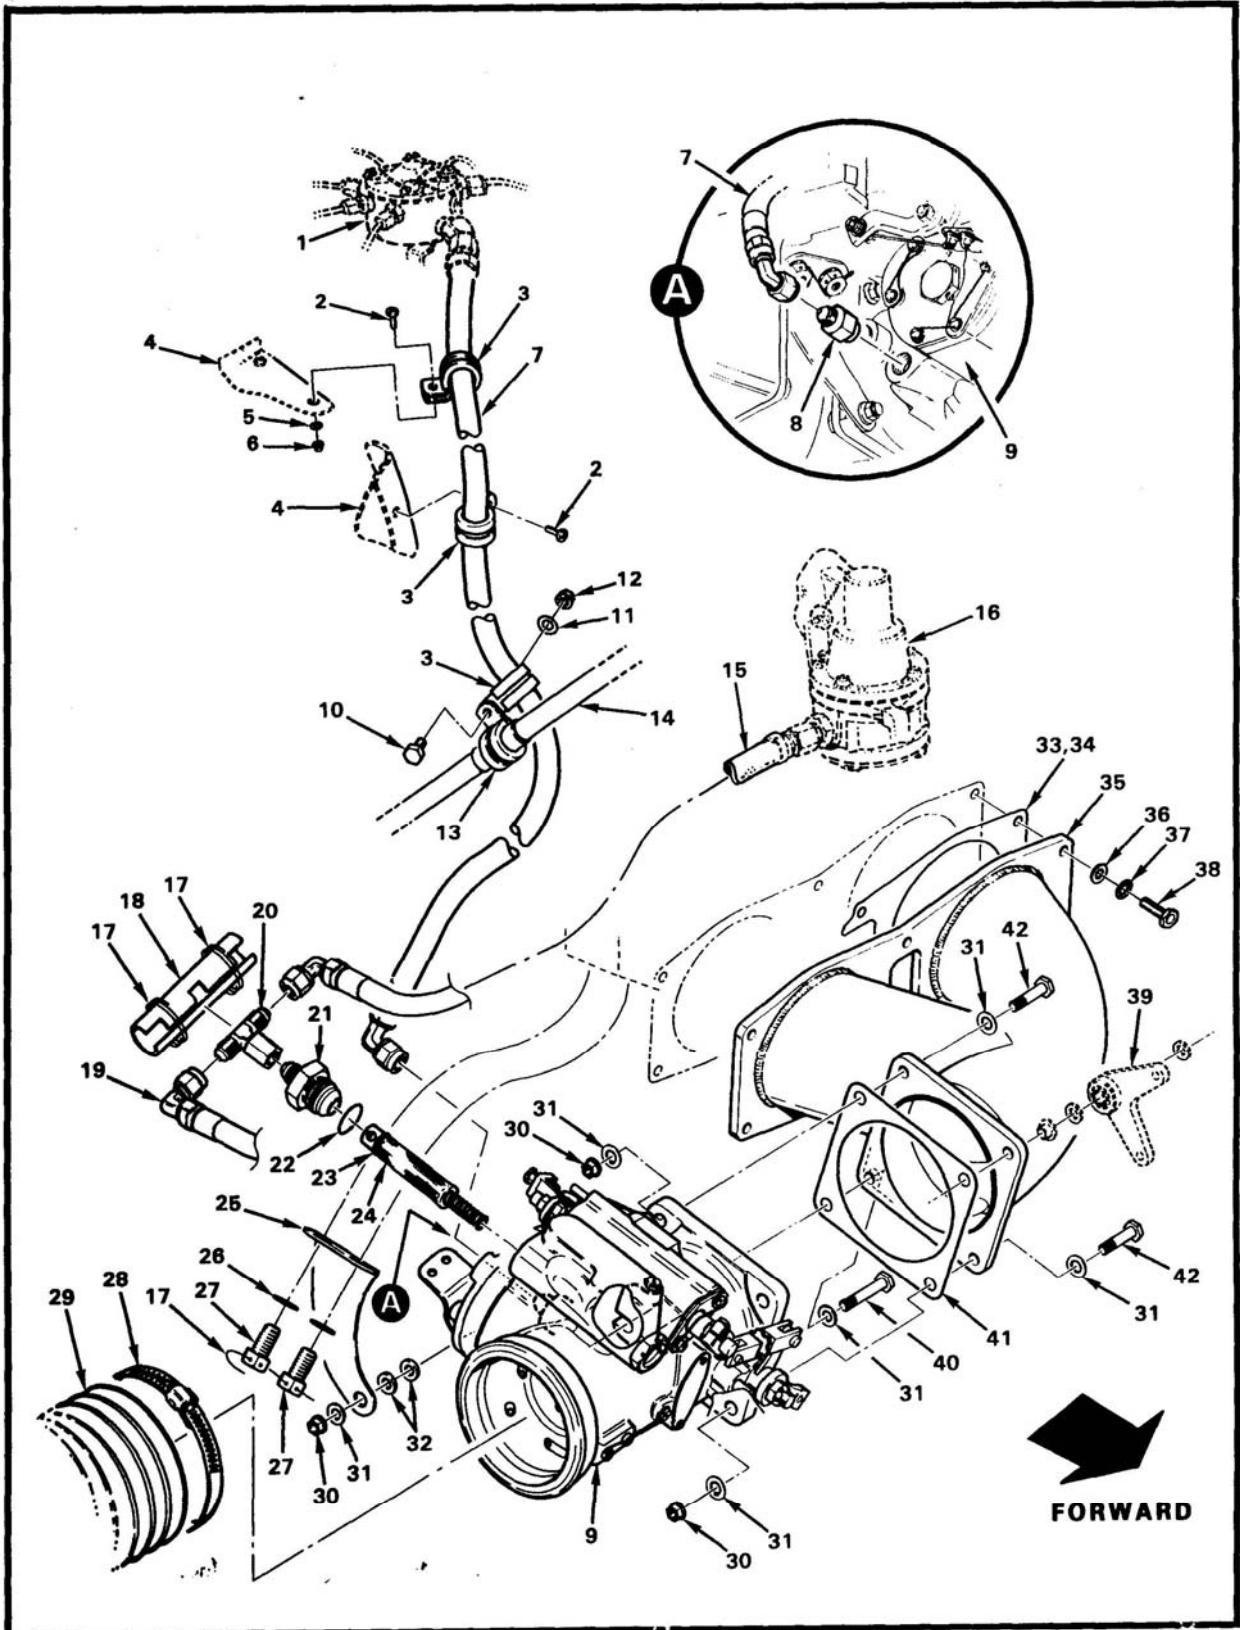
FIGURE 4-31F FUEL CONTROL INSTALLATION

ANTECEDENTES: Esta Advertencia pone en conocimiento del público usuario el Continuing Airworthiness Notice (CAN) N° 28-005 del 06-Noviembre-2008, emitido por la Autoridad de Aviación Civil de Nueva Zelanda, relacionado con un reporte de pérdidas de combustible en la unión de la manguera de entrada de combustible (P/N B283-10) a la Unidad de Control de Combustible (Precision Airmotive P/N 2576630-4). Dicha pérdida fue atribuida a que la unión de la manguera estaba insuficientemente torquada.

This CAN is prompted by a report of finding a significant fuel leak from the union of inlet fuel hose P/N B283-10 at the fuel control of a Lycoming IO-540 series engine fitted to a Robinson R44 II aircraft. The leaking fuel came into contact with parts of the hot engine and was discovered by the pilot after landing. The leak was attributed to the fuel inlet hose union being insufficiently torqued. The fuel inlet hose P/N B283-10 is connected to the Precision Airmotive fuel control P/N 2576630-4 at tee connector P/N 6600-04-04-04SS. The tee connector is covered by a heat wrap which must be removed to facilitate inspection of the hose unions.

RECOMENDACION: Esta Dirección recomienda prestar atención al procedimiento de ajuste y a los valores de torque cuando se ajustan mangueras de combustible. En la próxima inspección, remover el Sleeve (protección) P/N D735-1 que protege la unión T (P/N 6600-04-04-04SS) a la FCU y chequear el torque de los nipples (Precision Airmotive P/N 2577202) y las uniones tanto en las mangueras de entrada como en las de retorno de combustible de la FCU, de acuerdo con las consideraciones del párrafo "Recommendation" del CAN N° 28-005.

The CAA recommends that aircraft maintainers pay particular attention to the correct tightening procedures and torque value when tightening fuel hose unions. At the next scheduled maintenance inspection remove the heat wrap from the tee connector at the fuel control P/N 2576630-4 and check the tighten torque of the fuel fittings and unions of the fuel inlet hose P/N B283-10 and fuel return hose P/N B283-11.
