ANAC

ADVERTENCIA 119/DAG R1

MOTIVO: Posible falla de VÁLVULAS DE DRENAJE de combustible instaladas en los vasos colectores ubicados en los parallamas de las aeronaves.

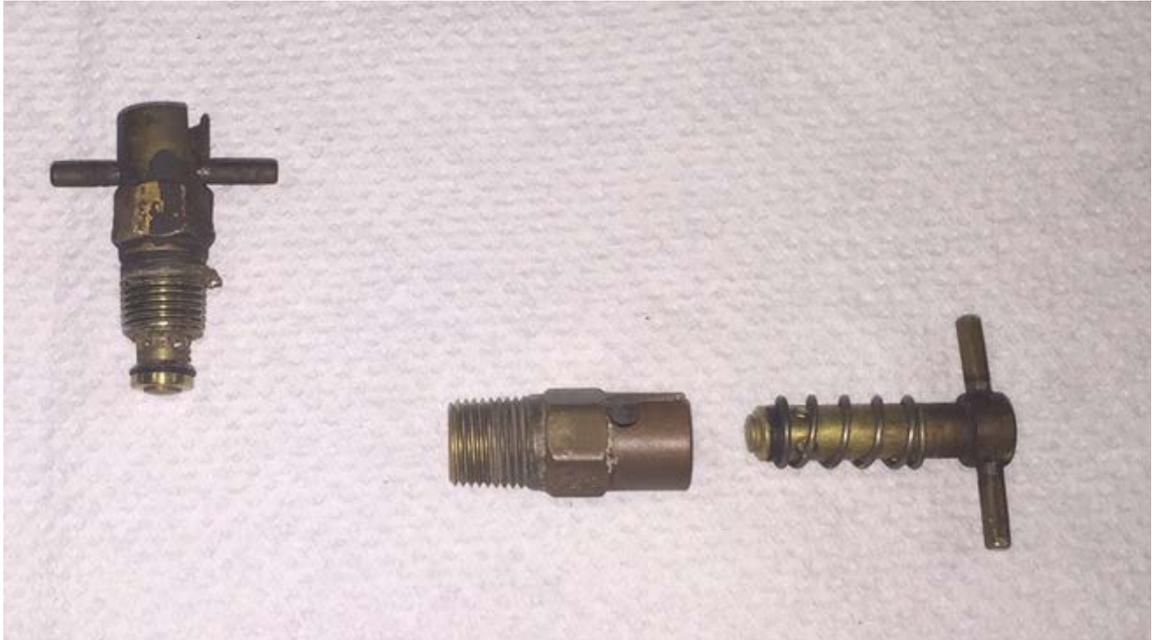
1. El 28 de mayo de 2010 una aeronave de Aviación General, al poco tiempo del despegue debió realizar un aterrizaje de emergencia a consecuencia de la detención del motor en vuelo. Se determinó que la causa de la detención del motor fue el agotamiento del combustible en el sistema, a consecuencia de una pérdida de combustible a través de la válvula de drenaje del filtro del parallamas (FUEL GASCOLATOR). La válvula era del tipo cargada a resorte, con apertura mediante giro de 1/2 de vuelta. Los investigadores detectaron, luego del accidente, que a la válvula le faltaba la parte móvil, que produce la apertura y el cierre de la misma. No se pudo determinar la causa de esta ausencia.

3. La fábrica Air Tractor también emitió una recomendación relacionada con este problema, mediante la SIL N°162, (se adjunta como ANEXO 2)
4. En mayo de 2015, se recibió un Informe de Dificultad en Servicio, en el cual se informa de la falla de una Válvula de Drenaje. En la fotografía adjunta se puede observar el estado en que se encontró la válvula, y próxima a la misma, una válvula de similar modelo pero en buen estado. Al ver en detalle la válvula que presentó la novedad, se aprecia que la falla se produce a raíz del desprendimiento de la arandela que actúa como "tope" para que el vástago no se caiga cuando la misma se abre. Esta arandela está fijada en el extremo inferior del vástago, en un sector dónde el diámetro de éste está rebajado. El armado final se produce mediante un proceso de remachado, y es justamente aquí donde apareció la novedad.

Tal como la FAA, se recomienda que antes de cada vuelo y en cada acción de mantenimiento que involucre el FUEL GASCOLATOR, se preste particular atención a la seguridad de montaje del Vaso Colector del filtro de combustible. Se debería verificar el correcto ajuste del vaso al soporte, el correcto estado del frenado del sistema de fijación del vaso, y la ausencia de pérdidas.

Tal como lo indica Air Tractor, cerrar suavemente las válvulas, evitando soltar el grip para que la fuerza restauradora del resorte la cierre, lo que podría provocar daños a consecuencia del golpe al alcanzar su asiento el vástago.

Asimismo se recomienda realizar una inspección detallada de la válvula de drenaje, para determinar la condición de todas sus componentes. Para lo cual es necesario removerla de su alojamiento, y verificar que la arandela de tope esté firmemente montada en el vástago, y su fijación no presente deterioros.

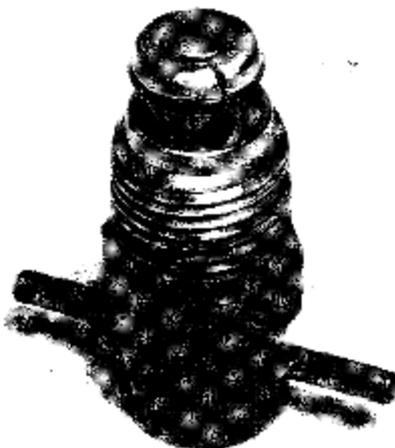
One of our customers has reported that the retaining ring at the end of the stem was cracked. If the retaining ring had cracked on the other side as well, the stem would have fallen out of the valve body, and all of the fuel would have been lost.

The cracked retaining ring is probably a result of allowing the stem to snap shut, with the force of the spring hammering shut the O-ring on the seat.

It is suggested that an immediate inspection of all drain valves be made, and that pilots and mechanics be instructed to ease the valve closed, rather than allowing it to snap shut. Any valve found with a cracked retainer ring must be scrapped.
