Service Information Bulletin 223/ DCA

Aeronautical Certification Department

Stabilizer Drains, Rudder and obstruction of wings by covers.

Aircraft PUELCHE PA25-235 / PA25-260

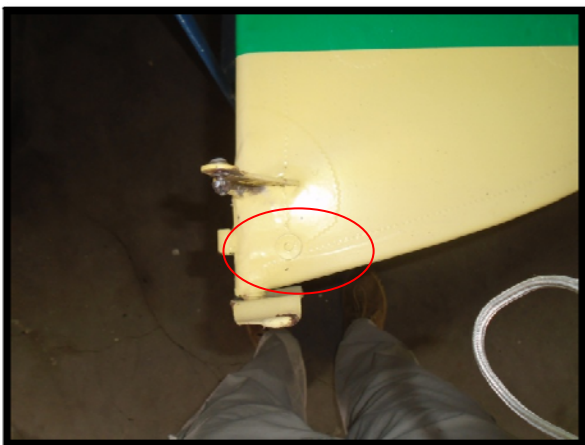
FIG1.-Rudder

In April 2015, a Difficulty-in-Service Report (DSR) was submitted to the Aeronautical Certification Department by the General Aviation Department stating that horizontal stabilizer drain holes and the elevator were not opened. Likewise, the report also specified that the cover was factory-set.

By conducting a sampling on Aircraft PA25-235/260, the DCA confirmed this finding, in addition to wing drain holes found next to the trailing edge (lower camber), which were not perforated.

To the purpose of avoiding buildup of water or any liquid used in fumigation and the subsequent appearance of corrosive processes in the structure, operators, users and aeronautical repair stations are being submitted this warning.
